# Analysis of the fire resistance of normal wooden doors exposed to fire conditions

**Keywords:** Fire safety, Fire door, Existing buildings, Fire resistance, Design requirements.

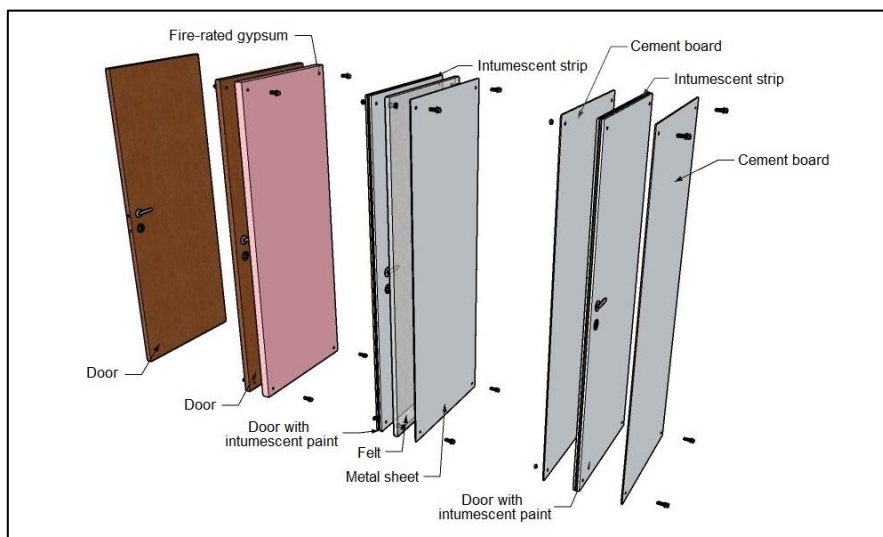
Identification	Composition/assembly
D1	- Wooden door
D2	- Wooden door - Fire-rated gypsum boards added to the fire-exposed face.
D3	- Wooden door with intumescent paint; - Polyethylene terephthalate felt board added to the fire-exposed face; - Metal sheet with intumescent painting on the fire-exposed side; - Intumescent strip placed within the door frame, next to the side of the door leaf that is directly exposed to fire.
D4	- Wooden door with intumescent paint; - Cement board of 12 mm with intumescent paint, placed on the side of the door leaf that is directly exposed to fire; - Cement board of 12 mm with intumescent paint, placed on the side that was not exposed to fire; - Intumescent strip placed within the door frame, next to the side of the door leaf that is directly exposed to fire.

Figure 1. Sample identification. Source: elaborated by the authors.

The wooden doors were installed on the masonry walls and then the samples were assembled. Table 1 names the samples and Figure 1 depicts the door schematics.

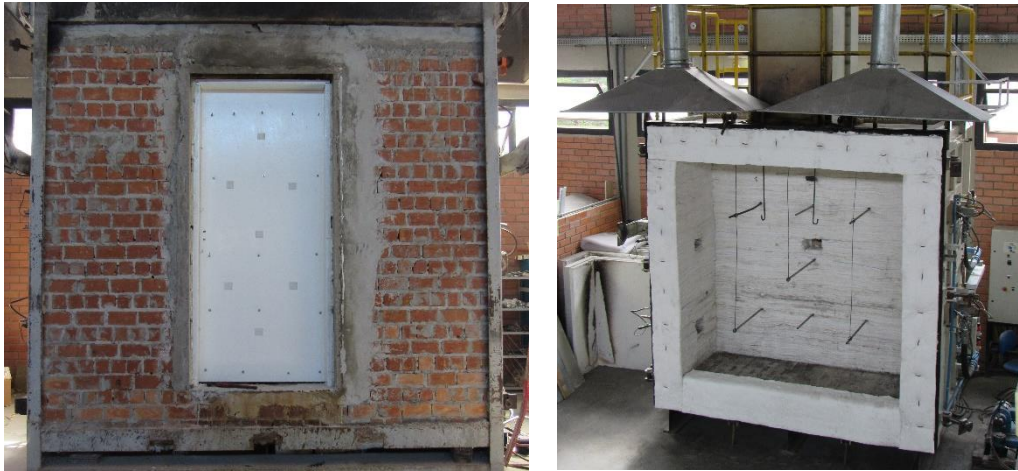
The fire resistance test for door and shutter assemblies was performed as per NBR 6479 (ABNT, 1992), in a vertical furnace (Figure 2), following the curve of ISO 834-1 (ISO, 1999). The room temperature at the beginning of the test was measured, and it must remain between 10 and 40°C throughout the test. Aside from the apparatus required by the standard, complements were used to help collect data during the test, like laser measure, thermographic camera, and digital chronometer with display to keep track of the test timing.

Figure 2. Sample assembled and vertical test furnace. Source: elaborated by the authors.

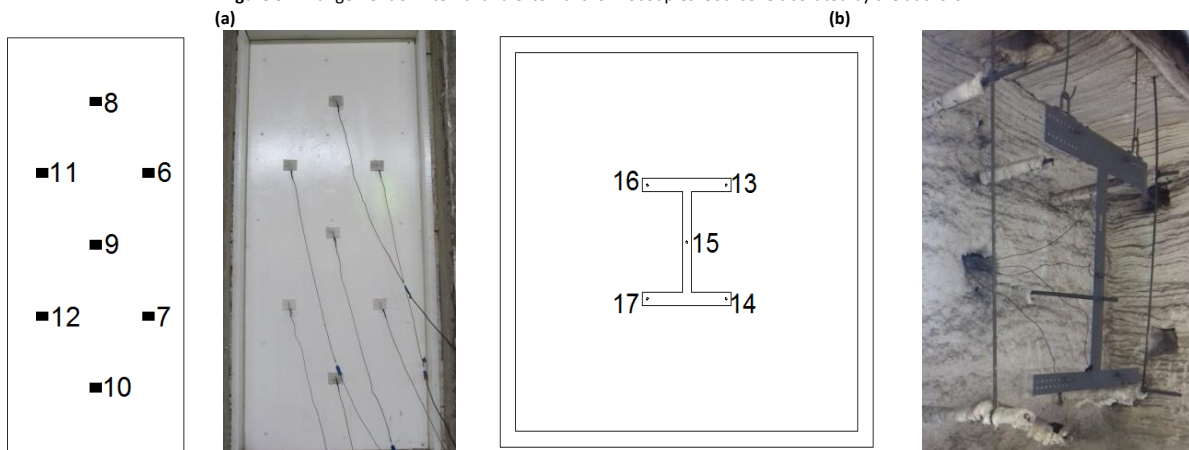
NBR 6479 (ABNT, 1992) requires a minimum of five thermocouples, one placed in front of the geometric center of the specimen and the others in front of the specimen vertices. The thermocouples must not be placed on the door hardware, nor within 30 cm and 15 cm, respectively, of the horizontal and vertical door edges. For each door test, seven external thermocouples (not exposed to fire) and five internal thermocouples were installed, which were respectively numbered as per Figures 3 (a) and 3 (b).

Figure 3. Arrangement of internal and external thermocouples. Source: elaborated by the authors.

Concerning the temperature of the internal thermocouples, for all samples, central thermocouple 15 recorded the lowest temperature values. During a fire, oxygen is the oxidizing agent that fuels the chemical reaction, therefore this event took place because thermocouple 15 is located on the middle of the sample and away from the gaps, where less oxygen is available. Thermographic images showed that the highest values for every sample took place on the sides and the top part of the sample. In case of indoor fires, hot gases and smoke dissipate by flowing upwards and spreading across the top layer and next to the source of oxygen, the side gaps.

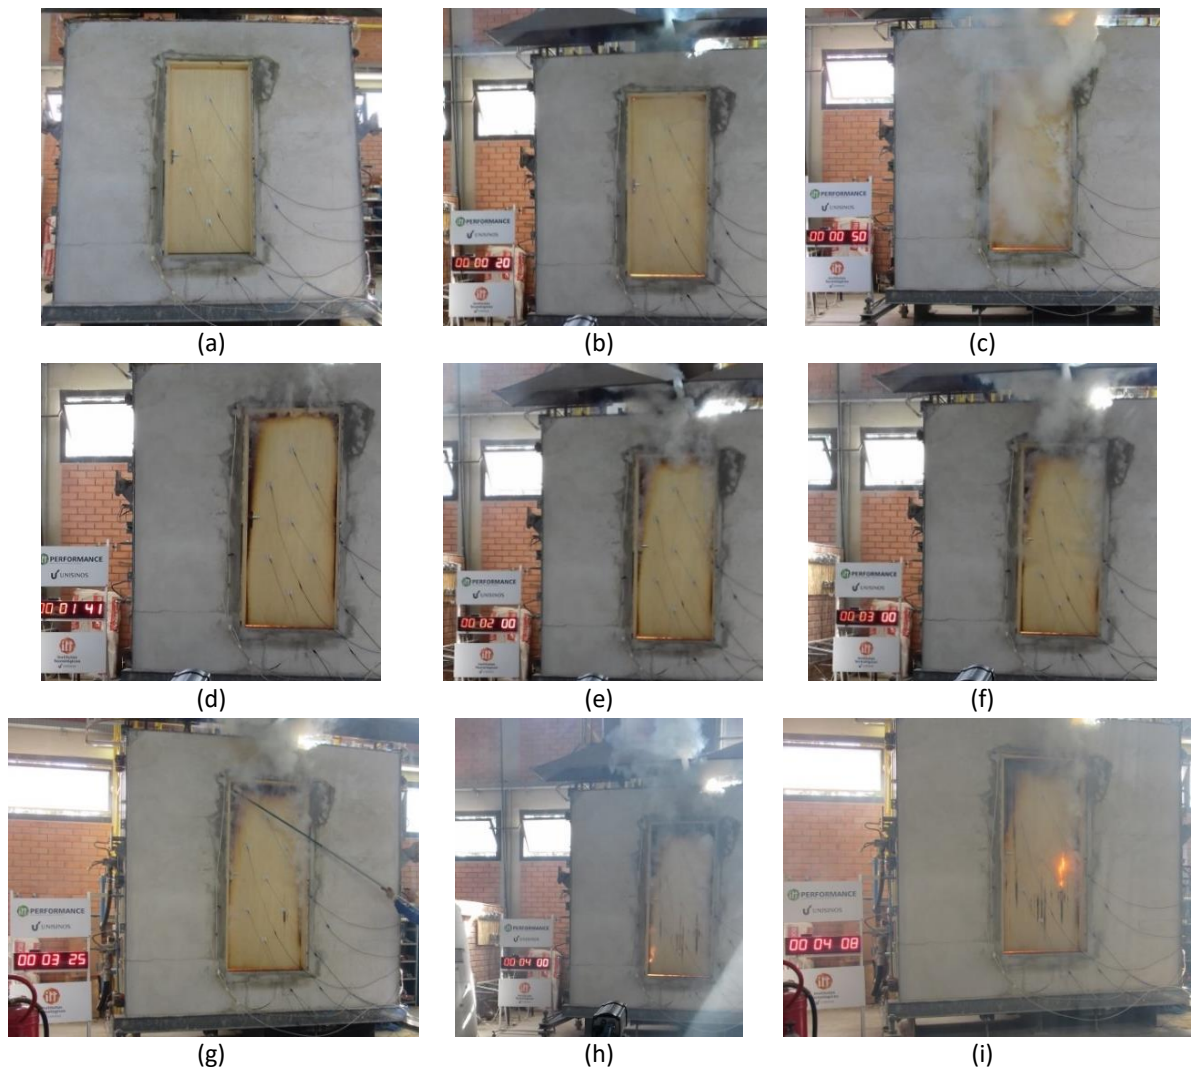
In the first part of the test, the masonry wall that contained door D1 was attached to the furnace (Figure 4a). The room temperature at the beginning of the test was 16.4°C, complying with the range set by NBR 6479 (ABNT, 1992).

At 20 seconds of testing (Figure 4b), smoke appeared and developed intensively in the seconds that followed (Figure 4c). At 1 minute and 41 seconds, the edges of the door leaf turned black and the burning wood crackled (Figure 4d). At 2 minutes, the crackles intensified (Figure 4e) and at 3 minutes the bottom part flared for less than 10 seconds (Figure 4f). At 3 minutes and 25 seconds of testing, the integrity test was performed without igniting the cotton wad (Figure 4g). At 4 minutes, the test was finished owing to the ignition of the door (Figure 4h). At 4 minutes and 8 seconds (Figure 4i), sparks were seen coming out of the door, which presented vertical cracks.

Figure 4. Test sequence for door D1. Source: elaborated by the authors.

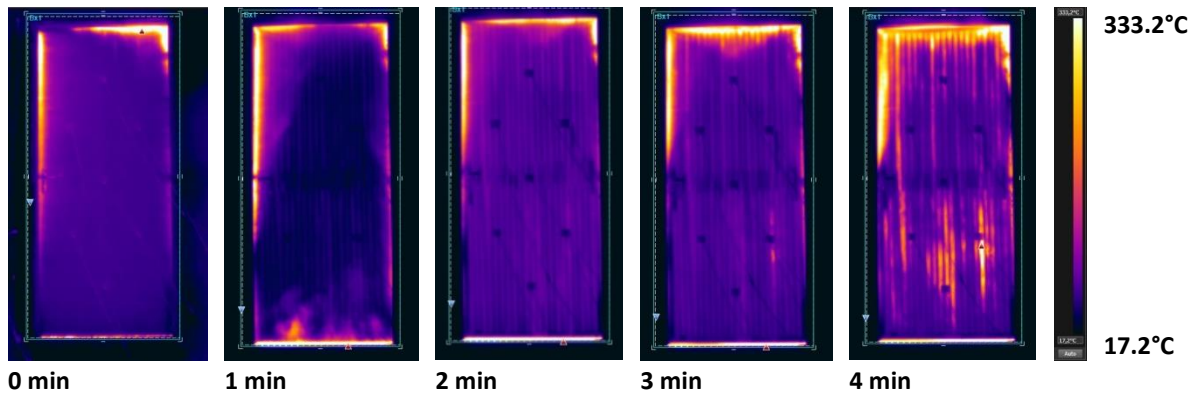
In order to evaluate the requirements for thermal insulation, which concern the increase of temperature on the unexposed face, the average temperature on the external thermocouples was taken. Figure 5 demonstrates that the temperature reached higher values on the top part of the sample, more precisely on the top and side corners.

Figure 5. Thermographic camera recordings for door D1. Source: elaborated by the authors.

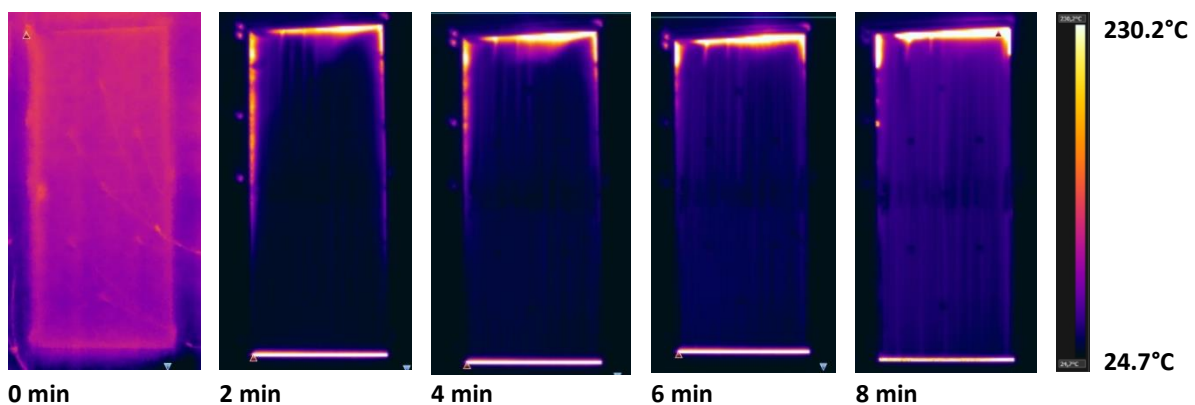
Figure 6 shows that the temperature acted more intensively on the top part of the sample. The absence of edge guards to protect the frame helped the flames reach the top edge of the door faster, revealing a weak spot between the door leaf and the frame. The temperature distribution on the external face of the door lead was different from that of the reference sample D1 and the fire-resistance rating was doubled.

Figure 6. Thermographic camera recordings for door D2. Source: elaborated by the authors.

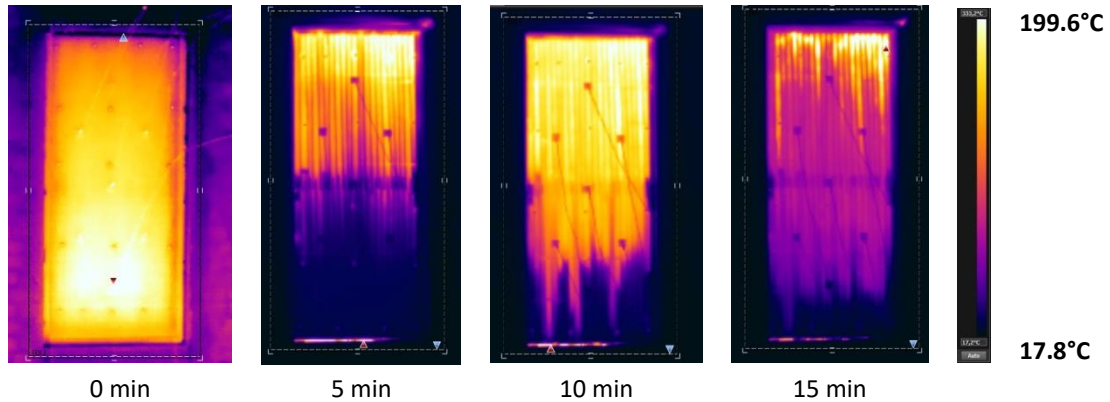
The test of door D3 yielded similarities with respect to the previous samples, with higher temperatures acting on the top part of the door, spreading to the other parts, as depicted in Figure 7. It should be noted that this sample comprised the interaction between 4 materials of different thermal properties, the intumescent paint, metal sheet, polyethylene terephthalate felt and wood.

Figure 7. Thermographic camera recordings for door D3. Source: elaborated by the authors.

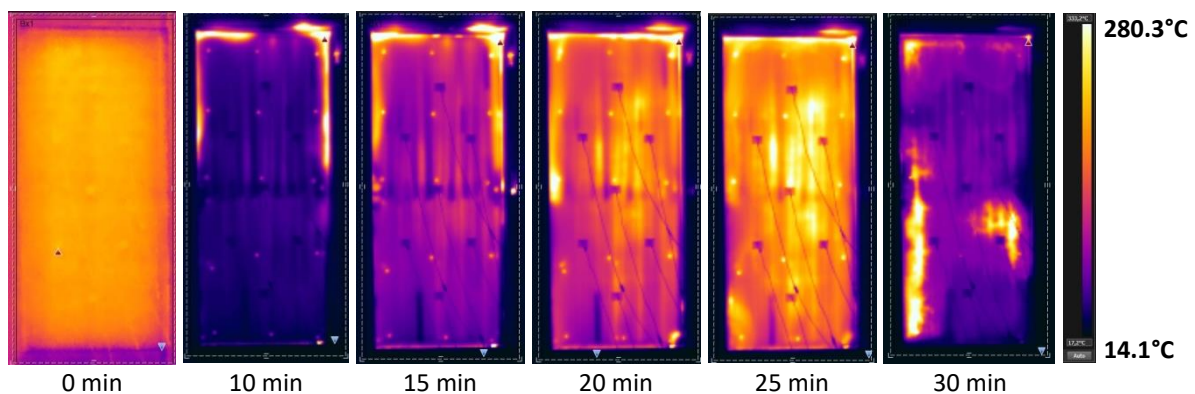
In the test of door D4, it was noteworthy that the temperature intensified by the top part of the sample and then spread to the other parts, just like had happened with the other samples. Figure 8 depicts the temperature evolution along the test.

Figure 8. Thermographic camera recordings for door D4. Source: elaborated by the authors.

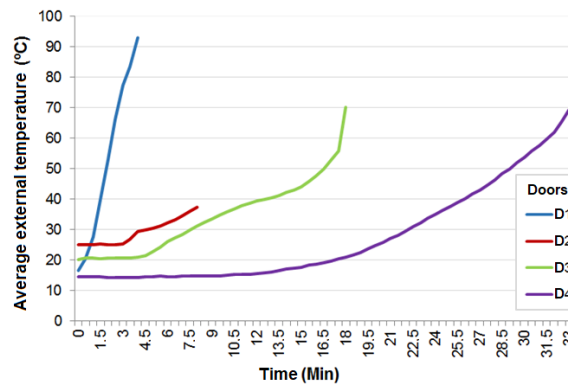
The average temperature of the external thermocouples of doors D2, D3 and D4 was lower than that of door D1. Figure 9 plots the average values that were measured over the testing time of each door. It can be noted that the temperature of door D1 grew faster than the others', while D4 maintained stable temperatures up to around 13 minutes of testing.

**Figure 9.** Comparison between average temperatures of external thermocouples. Source: elaborated by the authors.

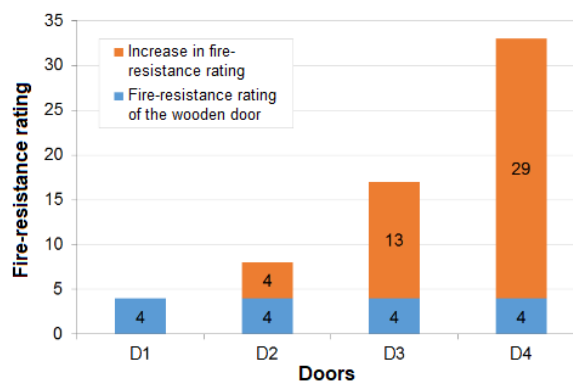
Finally, door D1 was tested with no insulation so as to estimate its resistance as a parameter for the other doors. Since door D1 resisted for 4 minutes, the additional fire-resistance rating of the other doors, owing to the use of fire-rated materials, was 4 minutes for door D2, 13 minutes for D3, and, 29 minutes for D4, as depicted in Figure 10.

**Figure 10.** Increase in fire-resistance rating. Source: elaborated by the authors.

Therefore, as per NBR 6479 (ABNT, 1992), the only sample that fits the category of fire door with minimum fire-resistance rating of 30 minutes is door D4.
